Opening the River: Fish Passage Dams on the Cannon

Anna Holman, Conservation Program Manager
Clean River Partners

December 16, 2025

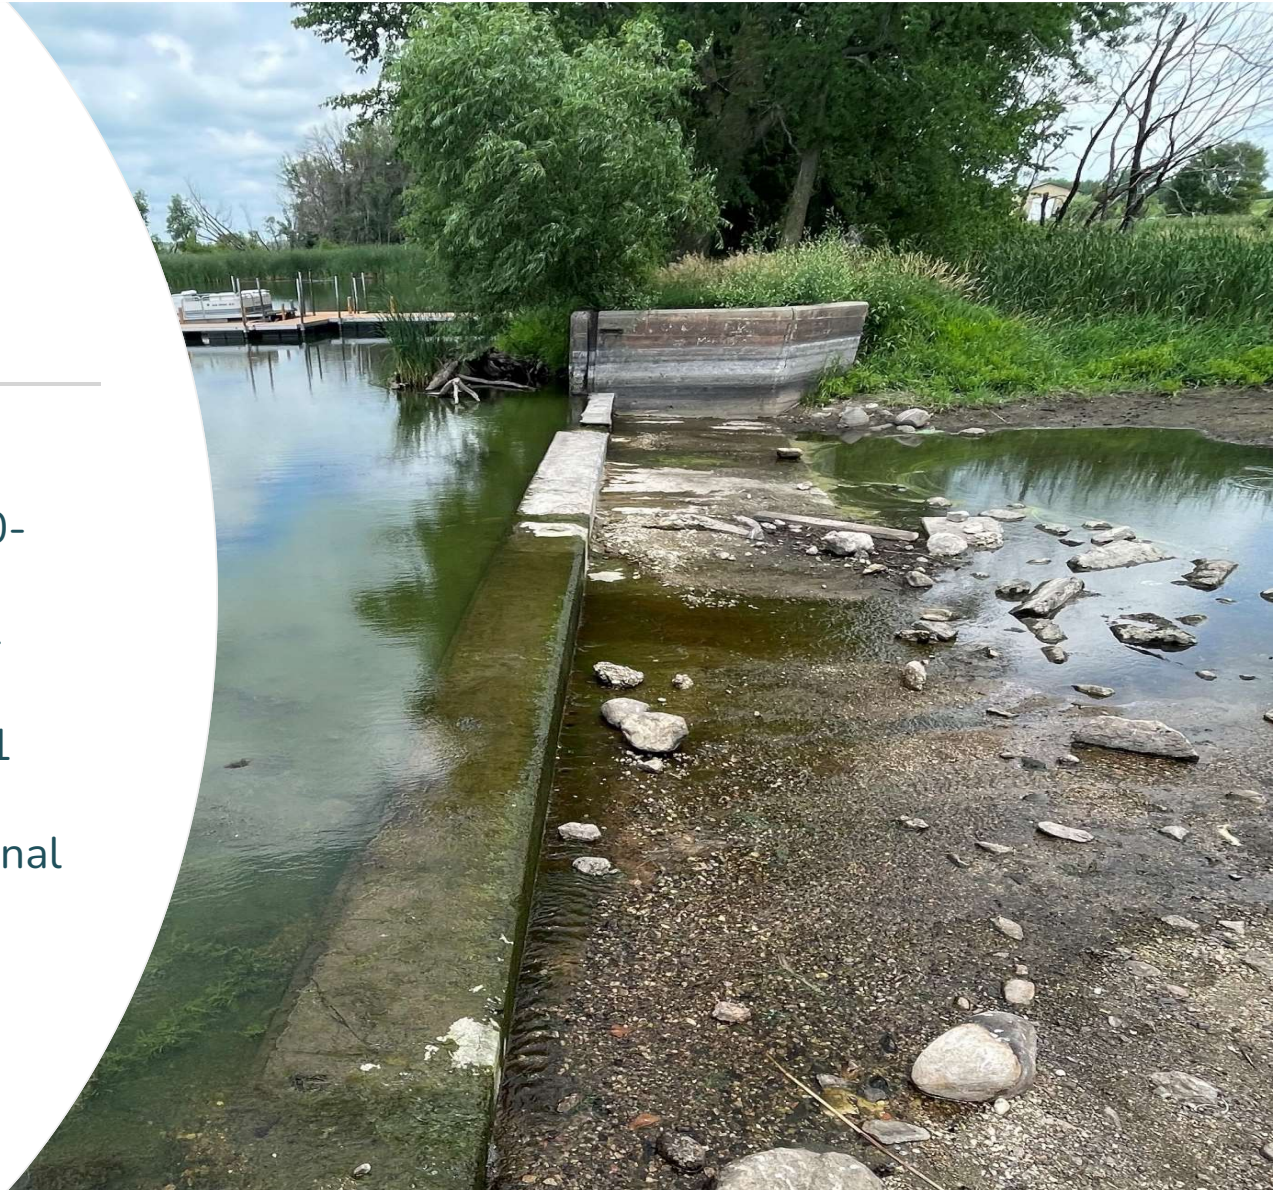
Concerns with dams

Aging structures:

- Many dams were designed with a 50-year life span in mind.
- The average age of dams in US is 64 years old (NID)
- The average age of dams in MN is 61 years (NID)
- Many dams no longer serve the original purpose they were built for

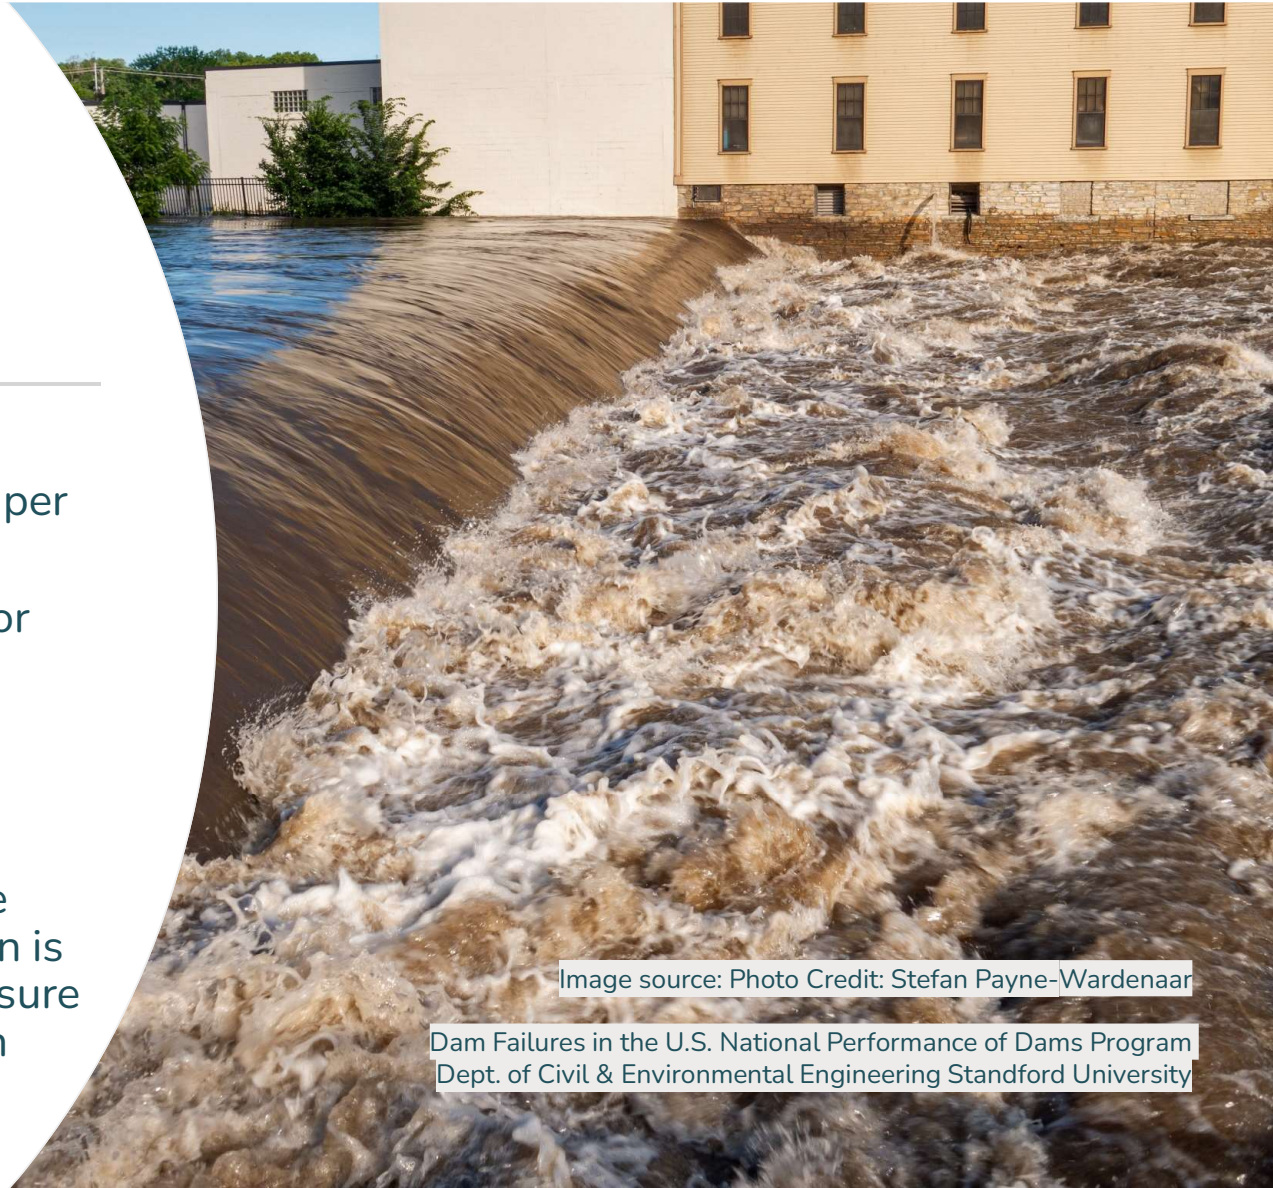
- 1848-2017, an average of 10 dams per year fail across the United States
- Dam failures are typically due to poor maintenance, inadequate design, unusually large floods, or improper operation

- As dam structures age, maintenance increases. An estimated \$103 million is needed over the next 20 years to assure public dams remain in safe condition (MN Dam Safety)

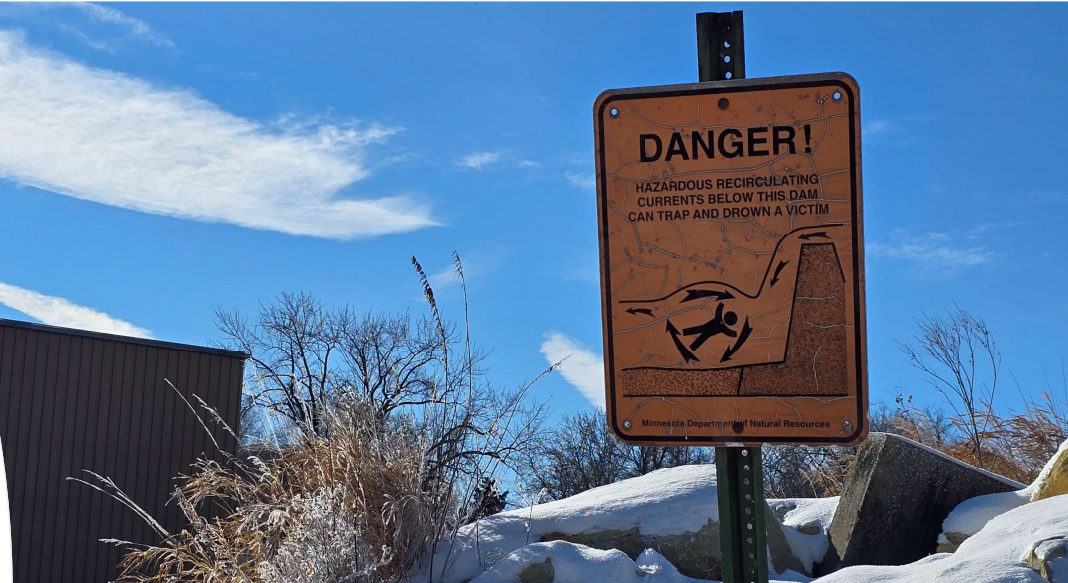
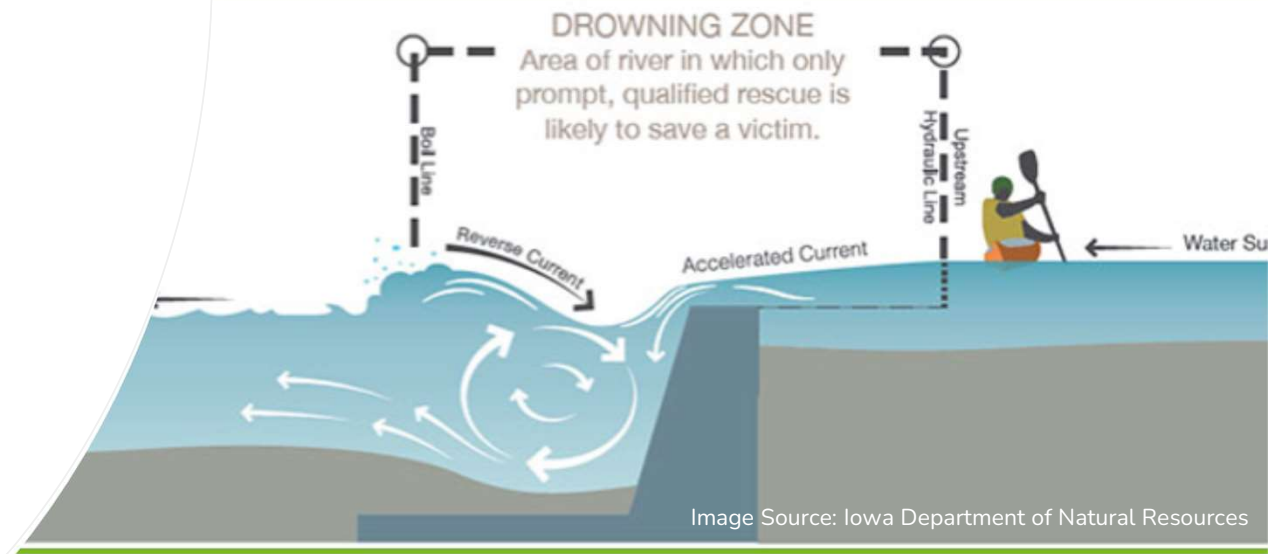
- Water flowing over low-head dams create a dangerous hydraulic roller that can trap and drown swimmers, boaters, and kayakers.

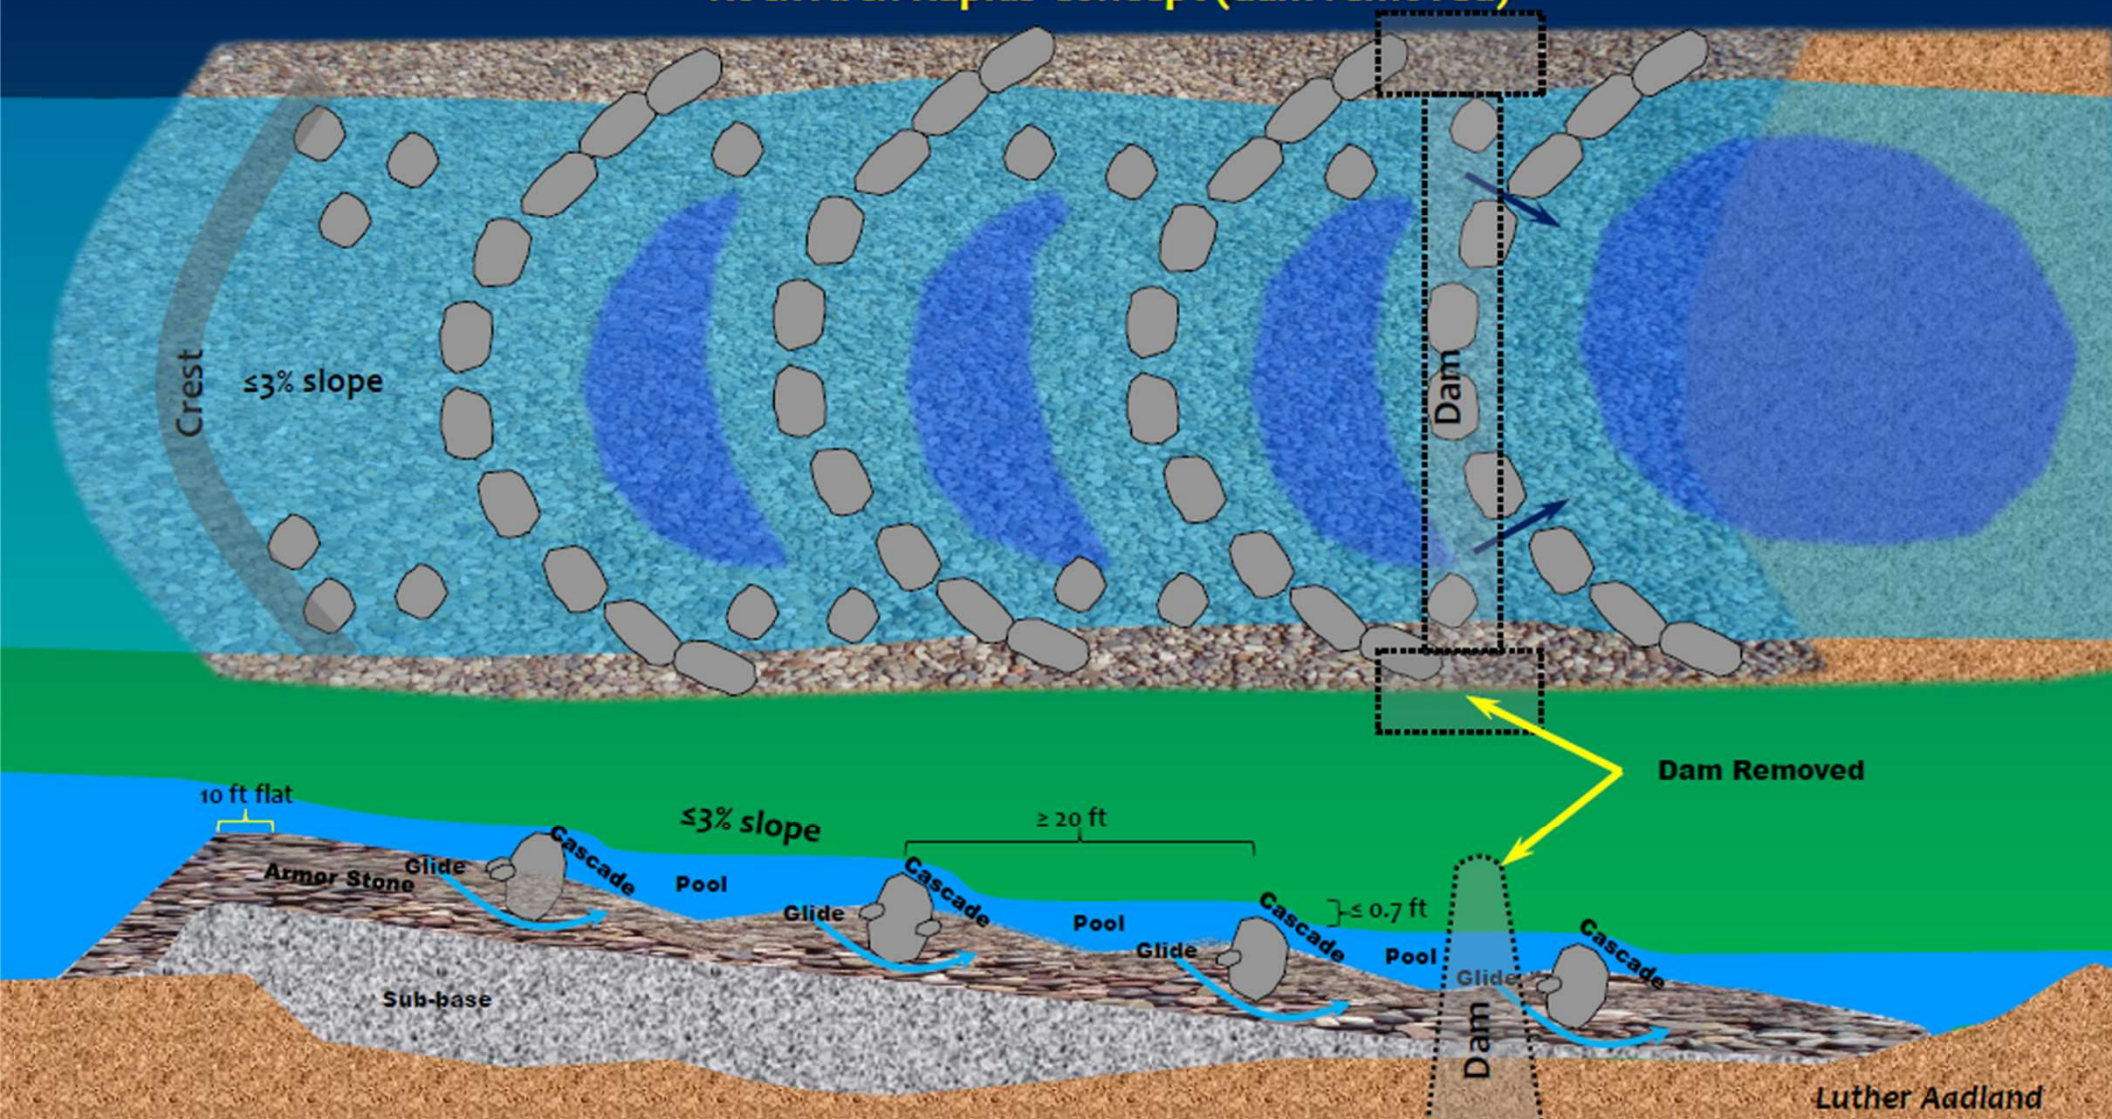
Rock Arch Rapids Concept (dam removed)

- Each RAR is designed specifically since each river site is unique
- RAR is composed of a rock ramp base that replaces the abrupt drop in water level with a gentle slope
- Each weir has strategically placed gaps to allow for fish passage
- Most MN fish species do not jump
- Resting pools between the weirs allow for recovery

The diagram illustrates the Rock Arch Rapids Concept in two parts: a plan view (top) and a cross-section view (bottom).

Plan View (Top): Shows a river channel with a $\leq 3\%$ slope. A dam is located on the left. The channel is filled with rocks arranged in a series of arches. Blue shaded areas represent pools of water. Arrows indicate the flow direction downstream.

Cross-section View (Bottom): Shows the riverbed structure. The dam is on the left. The riverbed consists of a **Base Stone** layer and a **Sub-base** layer. The riverbed is sloped at $\leq 3\%$. The structure includes a series of **Cascade** and **Pool** sections. The distance between the first and second cascade is ≥ 20 ft. The height of the cascade is ≤ 0.7 ft. The width of the pool is $\geq 2D_{50}$. The flow direction is indicated by a yellow arrow pointing downstream, labeled **Downstream hydraulic control**.

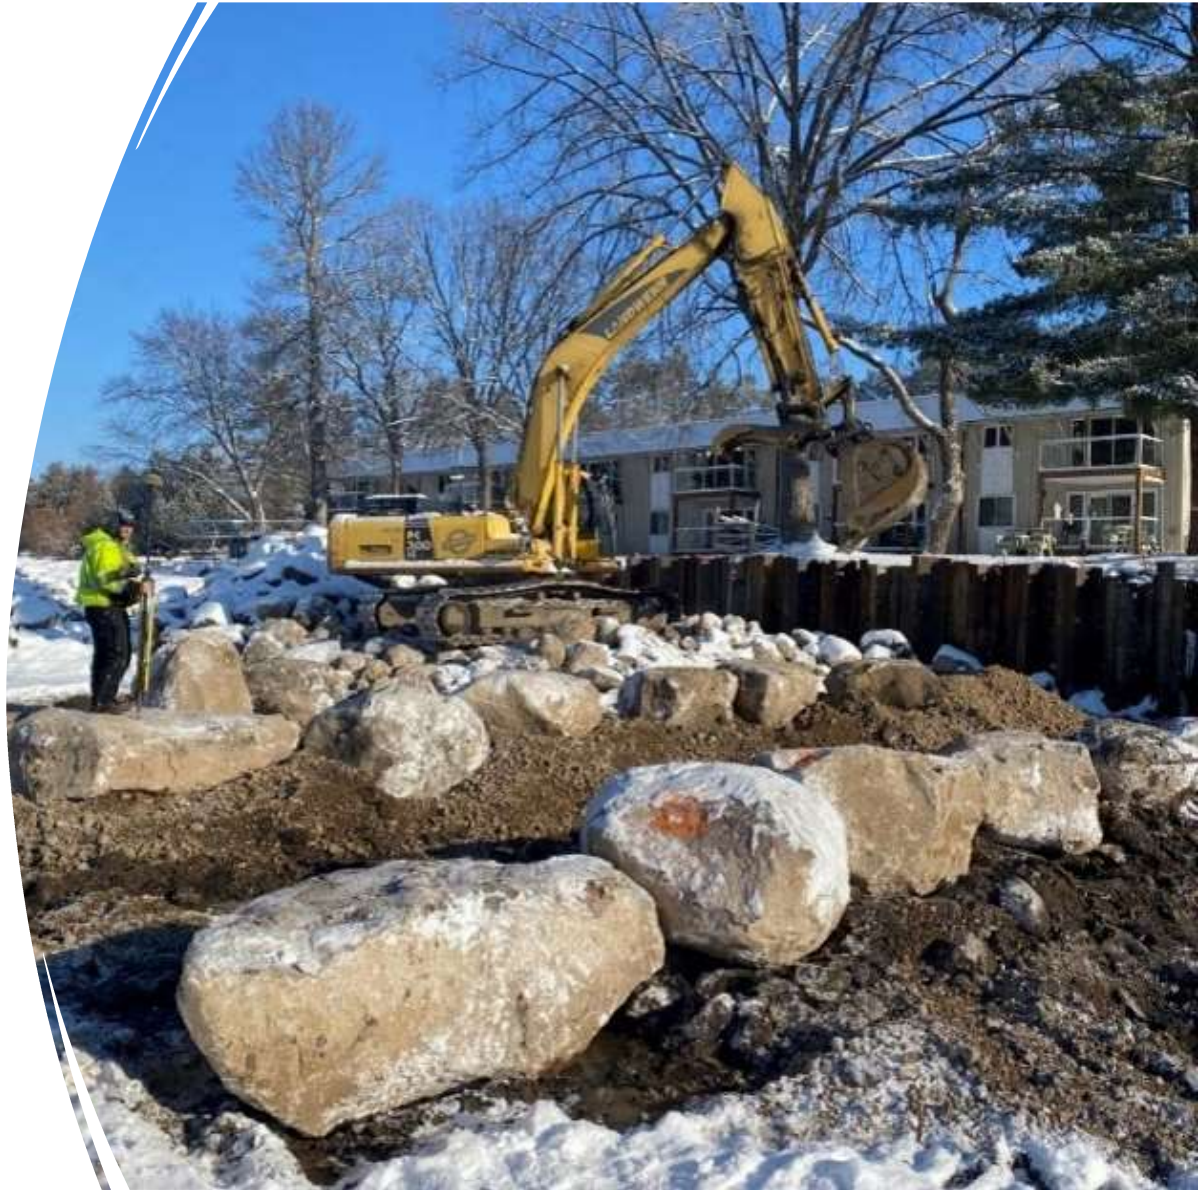
- Typically done in the winter
- Minimizes the damage to surrounding ground
- Flows tend to be low facilitating work in the water
- Less likely to have a flood pulse occur during construction

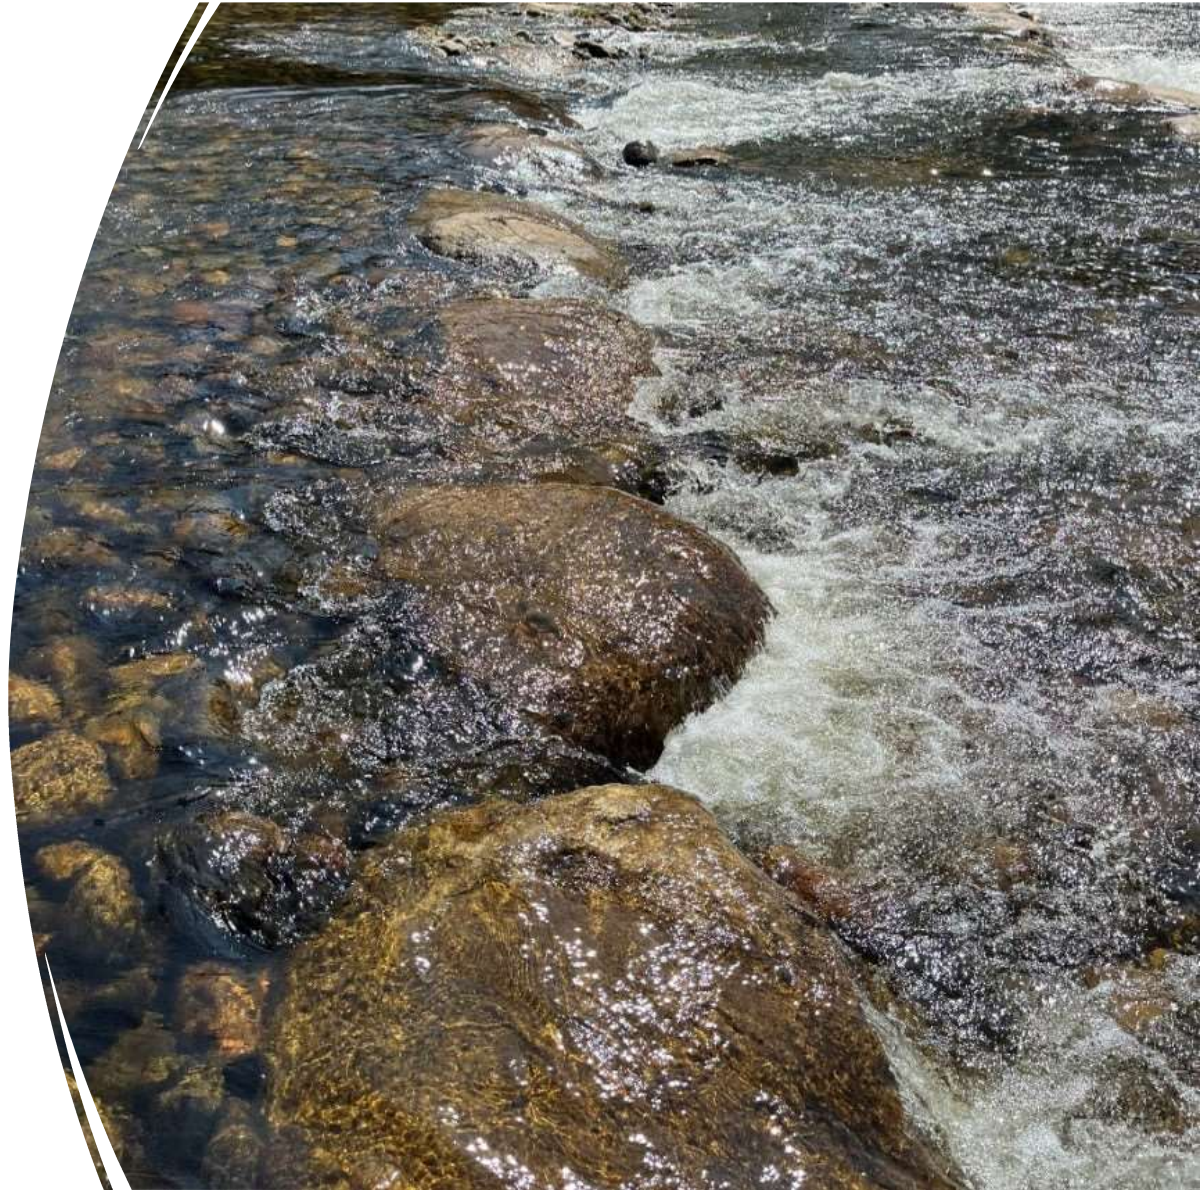
- Each weir has strategically placed gaps to allow for fish passage.
- Most Minnesota fish species do not jump but rather burst within the water column to pass high velocity areas.
- Resting pools between the weirs allow for recovery.

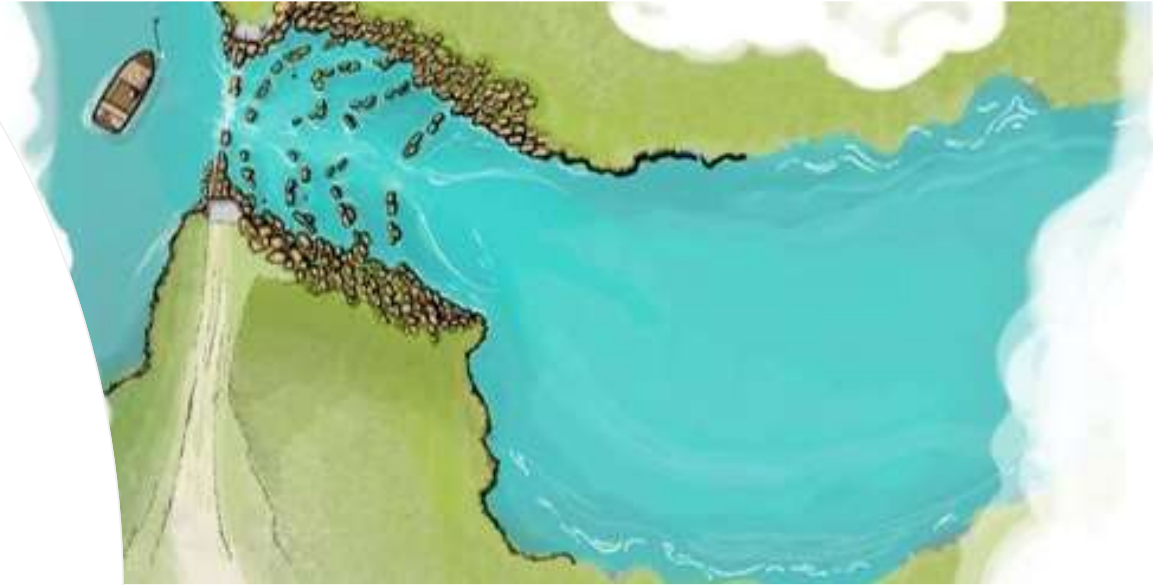
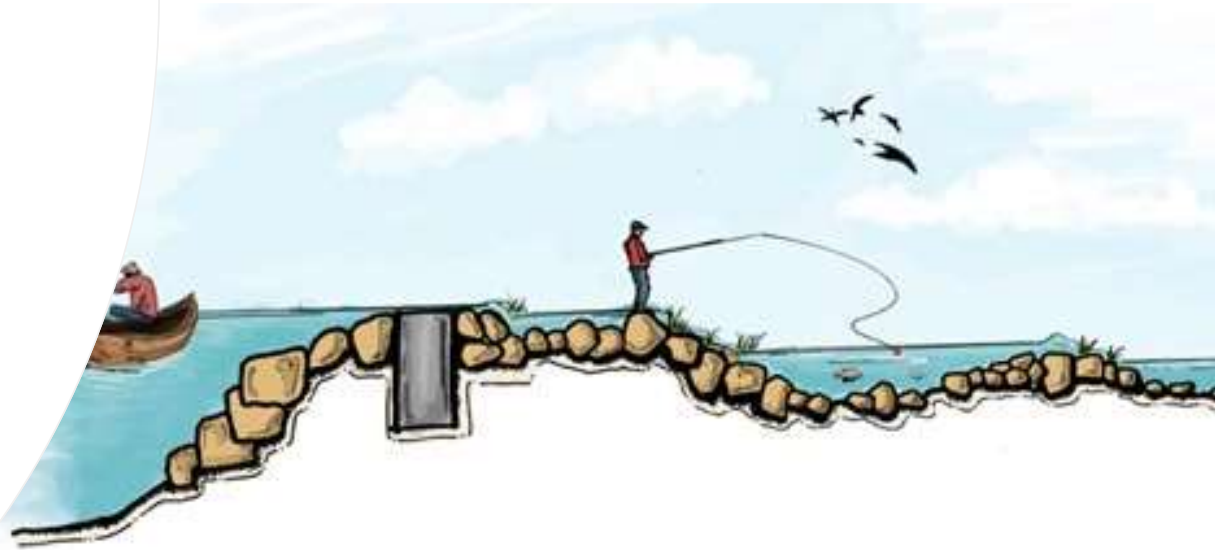
- Original structure built in 1936
- Retain concrete sill at current elevation
- Install rock and boulder rapids downstream
- Dam and Dodd Road culvert downstream are both fish barriers during specific flows

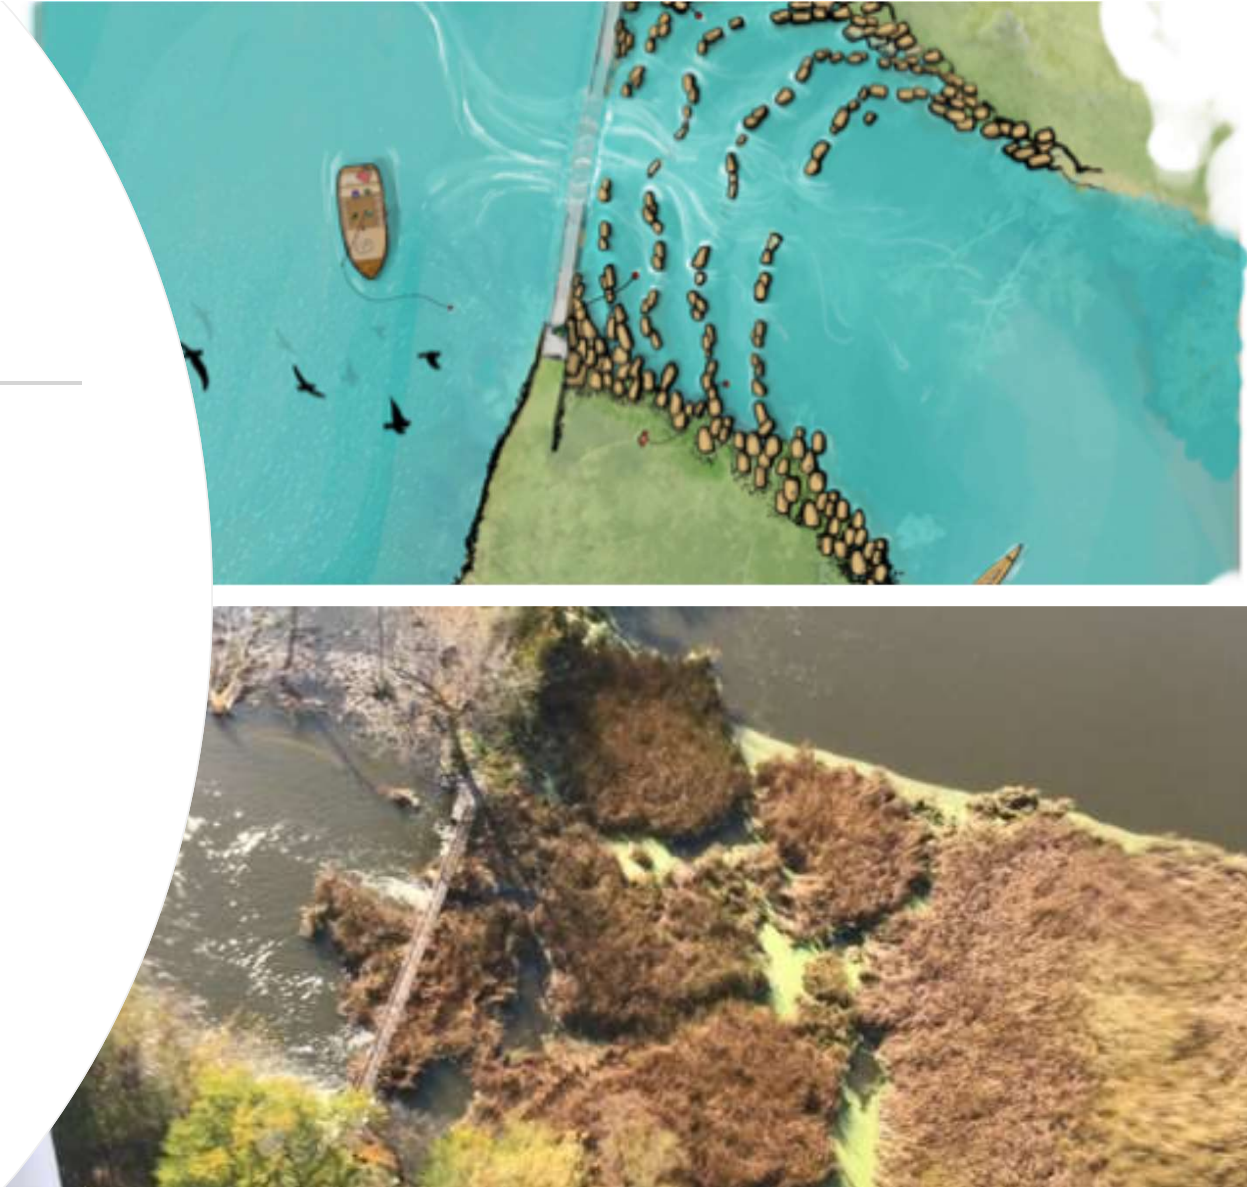
- Original structure built in 1938, modified in 1994
- Piers, railing, and bridge removed.
- Retaining concrete sill at current elevation and installing rock and boulder rapids downstream
- Flows deeper in the center of the outlet improve debris movement

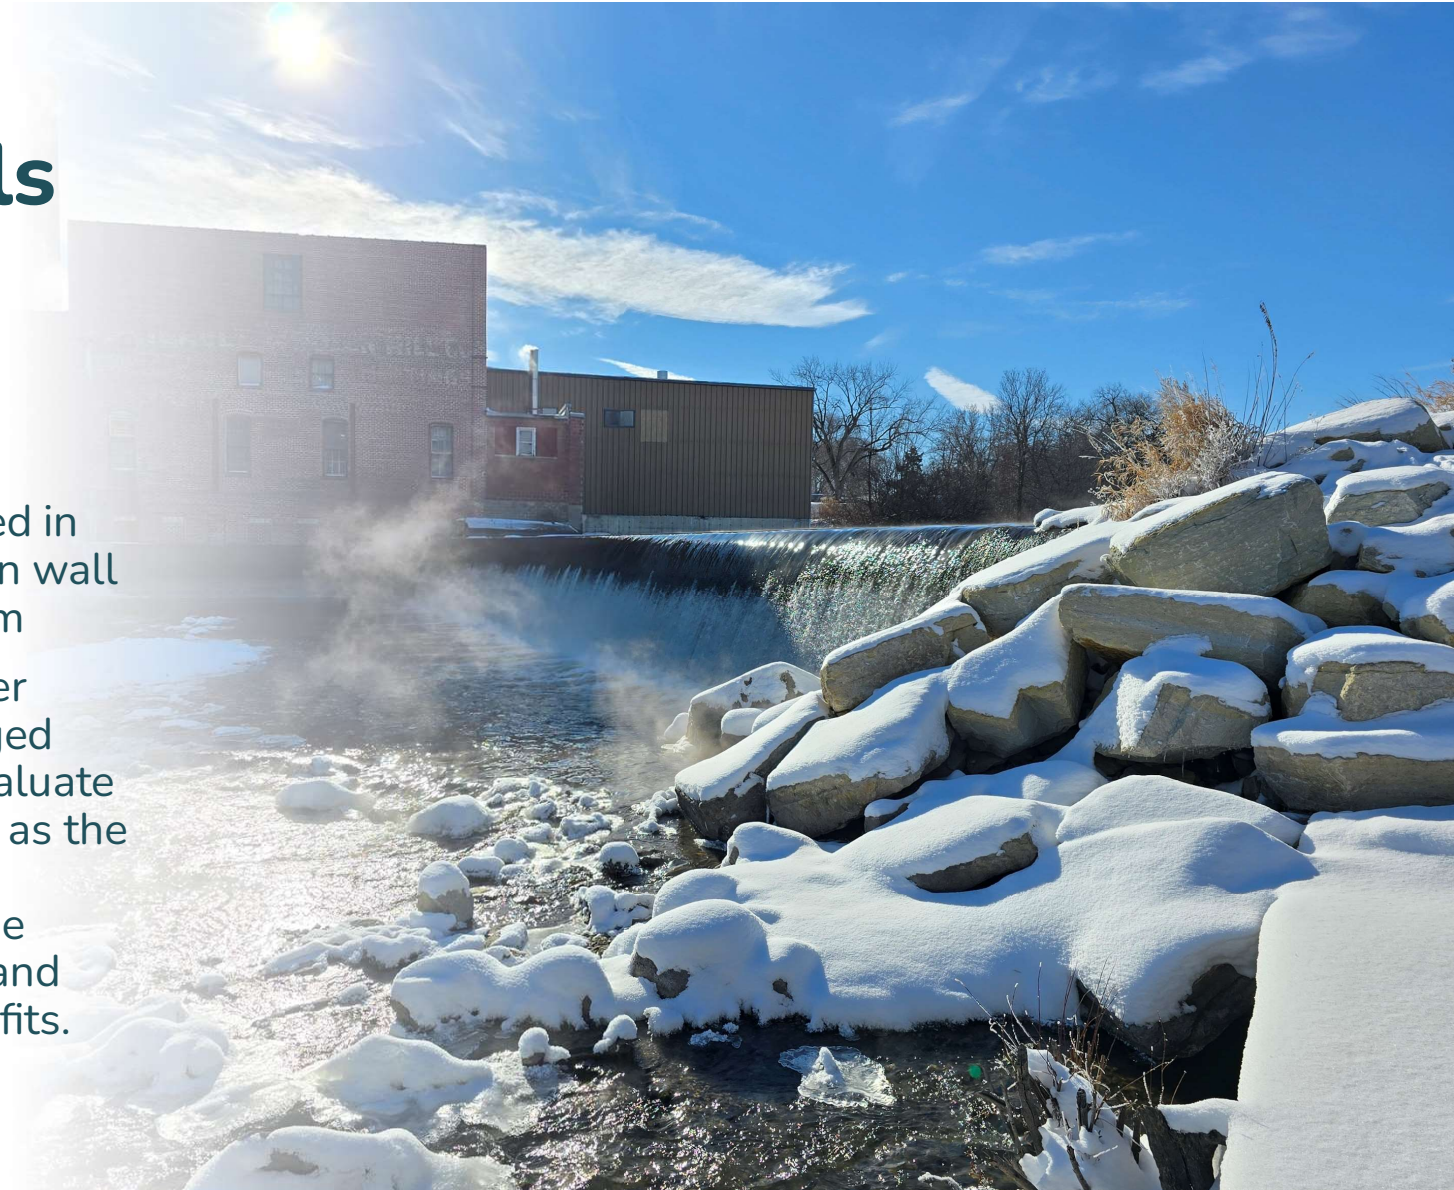
Ames Mill Dam

- Built in 1918
- Owned and managed by Post Consumer Brands
- Range of concepts are explored in the City of Northfield's Riverfront Enhancement Action Plan
- The City has conducted a dam study and explored ideas and options including preserve and repair existing dam or removing and reconstructing the area
- Feasibility study can be found on City of Northfield's website
